Manhole Inspection Summary

Manhole # S11CC1012MH

Location Address: **4000 EDGEWOOD RD**

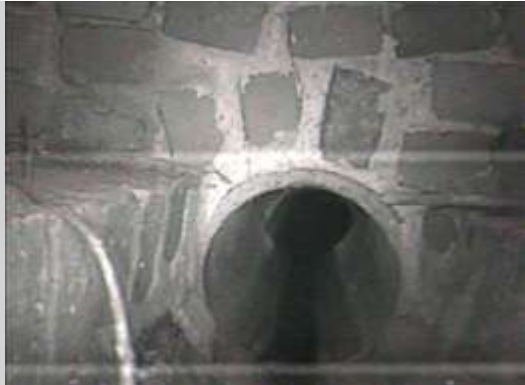
12 O'Clock Outflow

8 in. Circular Gravity Sewer
Pipe Out @ 12 O'Clock

Pipe Height: (in.) Direct
Pipe Material: **Clay** ☐ Pipe Lined
Invert Depth: **7.75** (ft.) Flow Characteristics: **Slow**
Deposits: ☒ None ☐ Mud ☐ Sludge ☐ Debris ☐ Grease
Silt Depth: (in.) Deposits Extent:
Infiltration: **None** Pipe Seal Cond: **Sound**

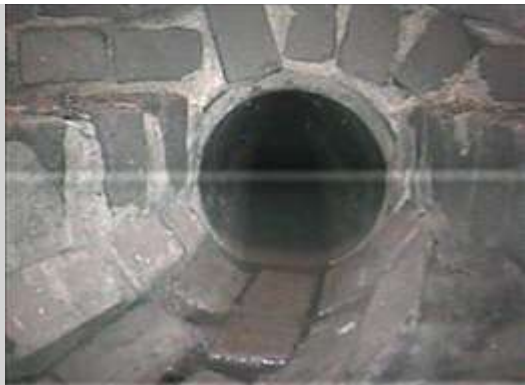
3 O'Clock Inflow

8 in. Circular Gravity Sewer
Pipe In @ 3 O'Clock

Pipe Height: (in.) Direct
Pipe Material: **Clay** ☐ Pipe Lined
Invert Depth: **7.70** (ft.) Flow Characteristics: **Slow**
Deposits: ☒ None ☐ Mud ☐ Sludge ☐ Debris ☐ Grease
Silt Depth: (in.) Deposits Extent:
Infiltration: **None** Pipe Seal Cond: **Sound**
